Langstaff Bowstring Bridge
Condition Report

PREPARED FOR
Schollen & Company Inc.

JULY 11, 2018
PROJECT NO: 2018-076

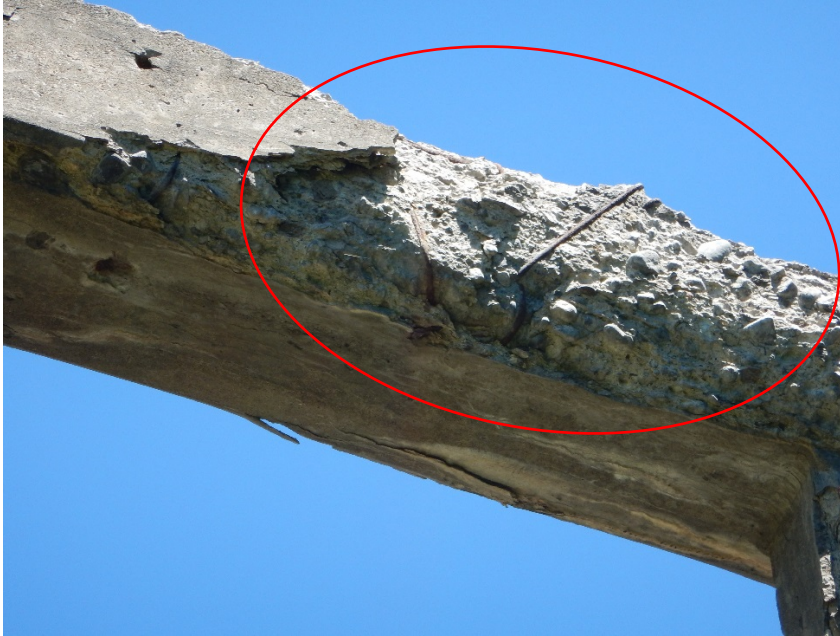
The south-east half of the arch has extensive spalling due to moisture damage from nearby vegetation growth which resulted in the loss of the outer 50mm to 75mm surface concrete on the top and side faces of the arch. The existing arch stirrups and top longitudinal rebars are partially exposed at areas of significant loss of concrete cover. The exact depth of water penetrations below and beyond the visible concrete surface is unknown. The deterioration of the south-east half of arch rib is the most serious distress on the bridge. It is the opinion of the writer that this portion of arch requires immediate remedial action to stop further deterioration and the continues loss of bridge capacity. To stop the on-going deterioration, the concrete surface should be restored with a partial depth concrete replacement coat with mesh reinforcing as soon as possible, before the 2018 winter conditions arrive. This will slow down the deterioration, but to restore the arch capacity, a surgical replacement of the damaged portion of the arch accompanied by construction shoring of the bridge will be necessary.

Close-up view of the south-east half of the southern arch, with serious spalling damages along top and side faces of the arch. Stirrups and longitudinal rebars are now partially and/or fully exposed due to the loss of concrete cover.

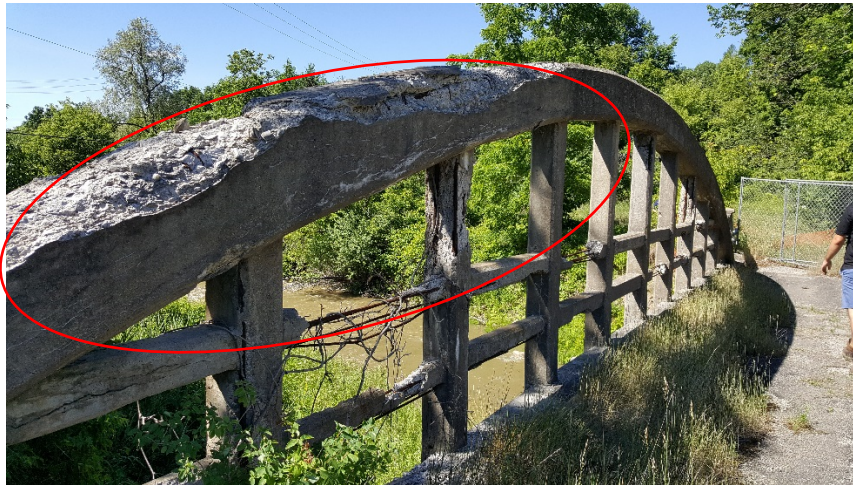
Total area of deteriorated concrete surface requiring immediate rehabilitation: 5.0 m2

Total volume of deteriorated concrete arch requiring replacement: 1.2 m3

Long shot view of the south-east half of the southern arch, showing the full length extent of the spalling damage. The damaged area should be parged with concrete coating as soon as possible, and then be surgically replaced if original bridge capacity is to be restored.

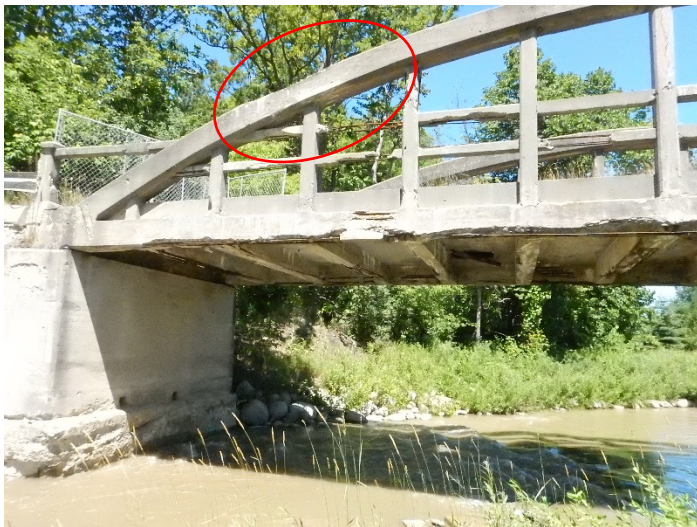
The remaining south-west half of the arch has limited chipping damage along the southern top corner of the arch towards the west end. The zone is small relative to the size of the arch, with the apparent depth of damage approximately 50 mm by 2000mm long. The limited depth of the damage zone indicates that this portion of concrete is repairable.

Total area of damage 0.5 m², typically 50 mm deep

South-west half of the southern arch, will spalling along top corner of arch

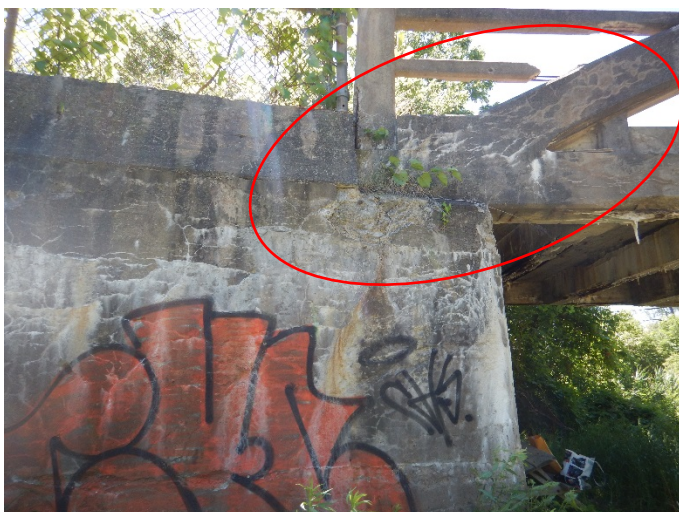
The northern arch rib is generally in good condition except for frost spalling damage observed on the east end of the arch. This zone with the spalling has some indication of laitance. The zone is small relative to the size of the arch, with the apparent depth of damage approximately 50 mm. No sign of delamination was noted in any part of the northern arch rib including the area with spalling. No reinforcing was exposed in the locations probed, and rust staining was not observed.

Total area of damage 4.0 m², typically 50 mm deep

Northern Arch Rib, east side, spalling near the arch end

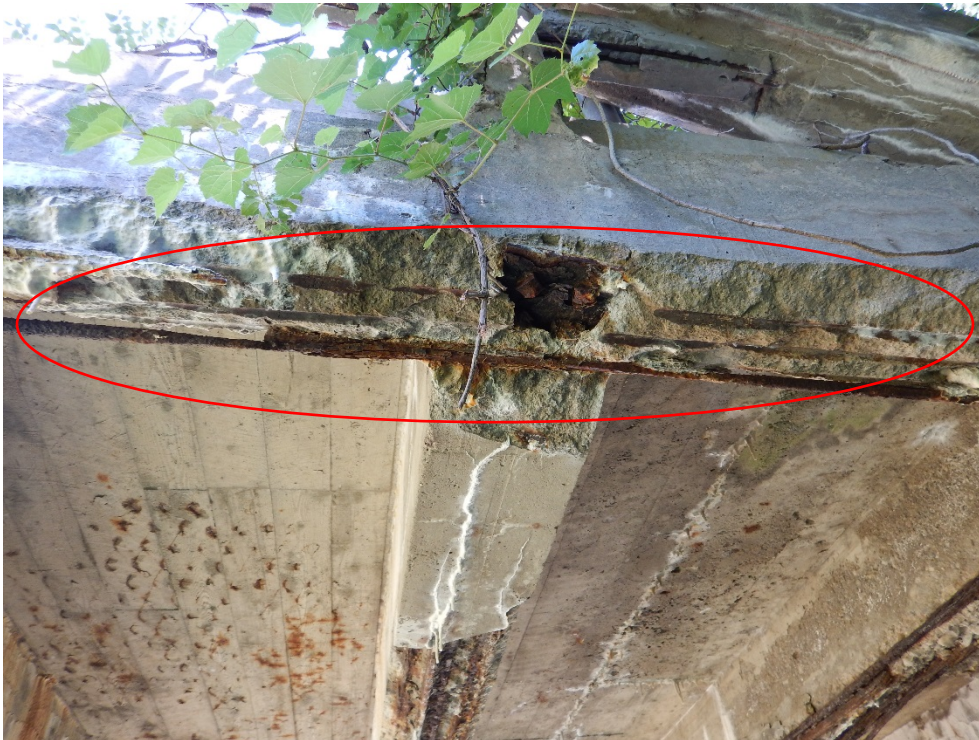
Extensive lengths of the two bottom chords have zones of spalling damage for the full width of underside surface. Vertical hangers and bottom longitudinal rebars are exposed at many locations.

Total area of damage The full length of the two bottom chords are damaged beyond local repair and must be replaced.

Bottom Chord, frost damage and spalling, with rebars and hangers exposed

The two bottom chords were previously condemned in the 2008 report. The 2008 report recommended the demolition and reconstruction of these components together with the sequential replacement of the deck substructure. This recommendation remains valid. All deteriorated vertical hanger end plate assemblies should be replaced at the same time given the opportunity.

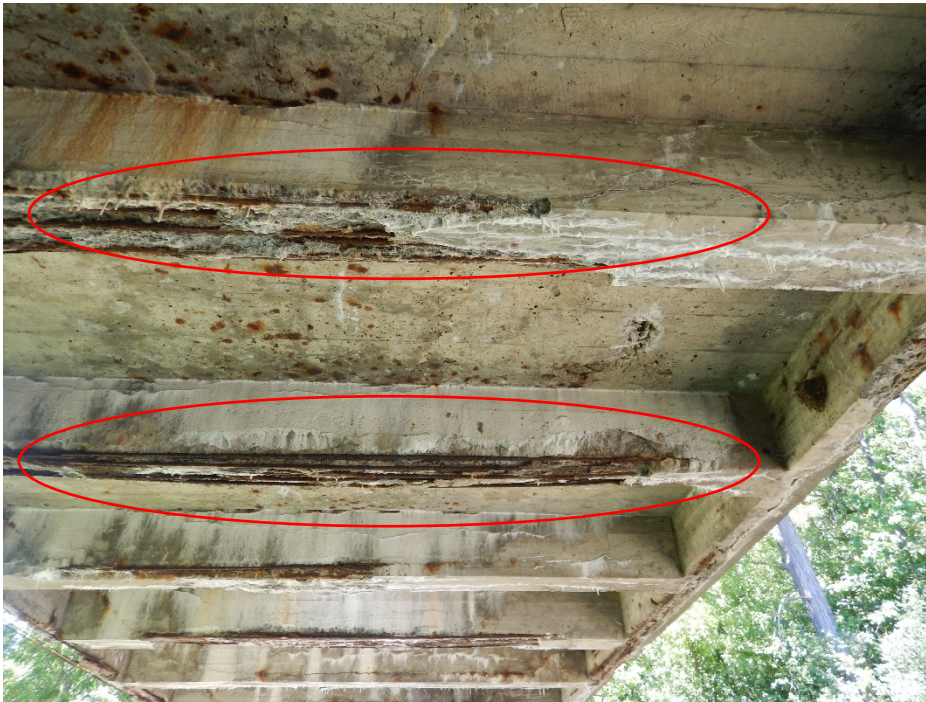
The majority of floor beams below deck have zones of spalling damage on the full width of underside surface. The bottom longitudinal rebars are exposed for a large number of floor beams.

Total area of damage: All 12 floor beams are damaged beyond repair and must be replaced.

Floor beam with exposed and fully corroded rebars

The floor beams were already condemned in the 2008 report. The 2008 report recommended the demolition and reconstruction of these components together with the sequential replacement of the deck substructure. This recommendation remains valid.

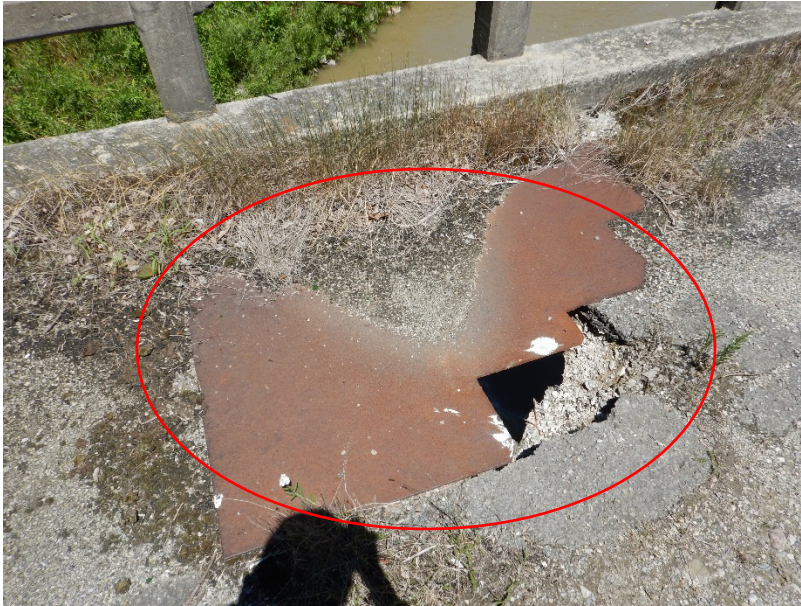
Large hole in the west end of deck, partially covered with a steel sheet.

The deck slab was already condemned in the 2008 report. The 2008 report recommended the demolition and reconstruction of this component together with the sequential replacement of the entire deck substructure. This recommendation remains valid.

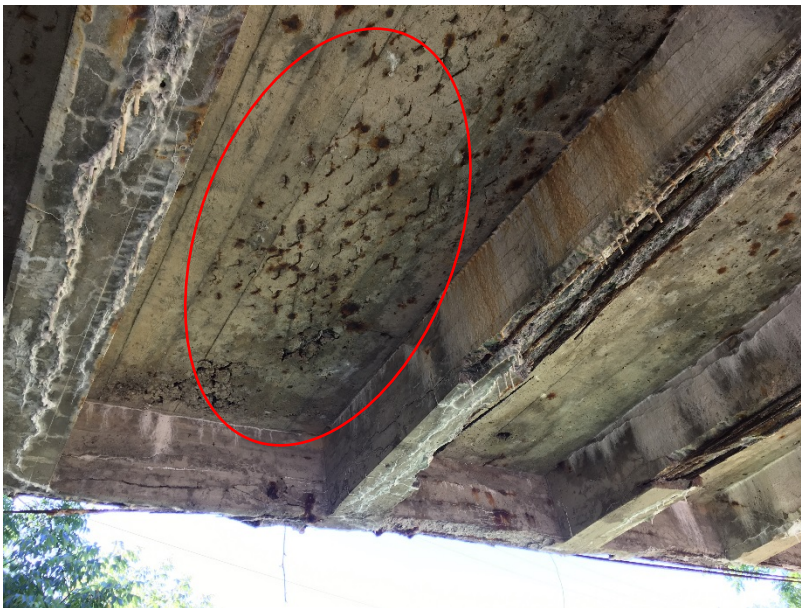
Rust stains visible at the underside of deck slab, indicating corrosion of the deck slab mesh reinforcing

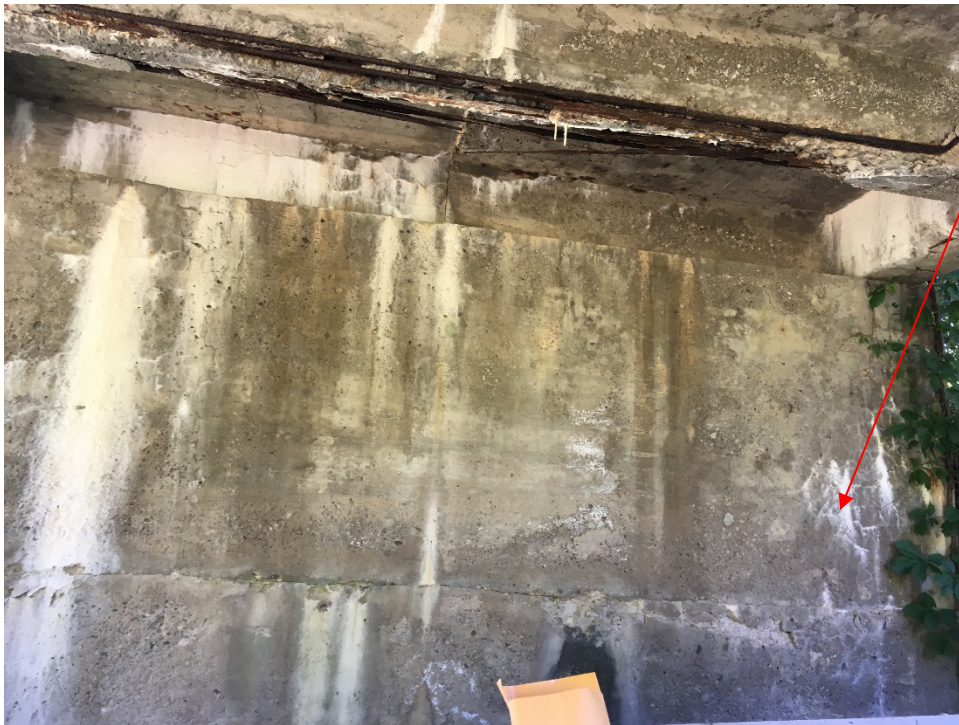
East abutment face
from west

The east abutment is generally in fair condition, with 20% of surface area having some degree of spalled and frost damage. The most developed frost damage is at the south east corner where the damage extends for a 4 m width for the full height, with some increase in width at the base. The north east corner had similar damage indicated. The face of the abutment directly under the bridge had limited vertical cracking but was generally sound. The bearing seat appeared generally fair to good with no repair required. The ballast wall was obscured and could not be evaluated, but is likely to have frost damage because of its location in the structure.

Frost damage

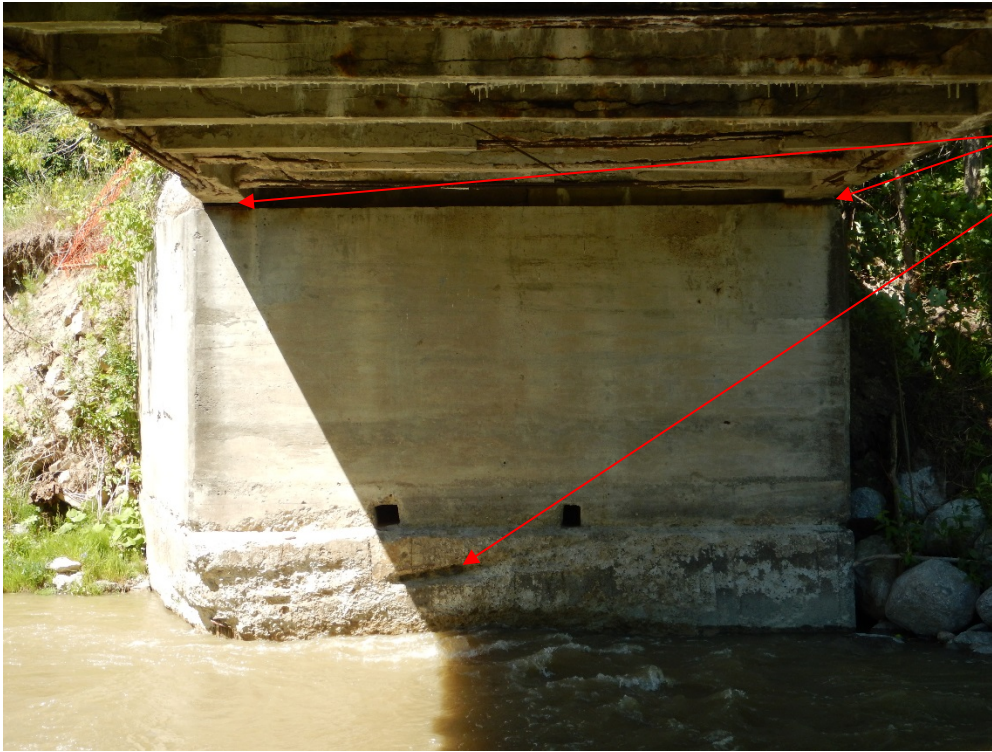
West abutment face
from east

The west abutment is generally in fair condition except for the bottom horizontal strip section of frost damage above the footing of the structure due to frequent exposure to the river water. The face of the abutment is sound as is the bearing seat. It has been assumed there will be frost damage in the ballast wall but it could not be directly observed. Damage to the ballast wall would not be critical to the bridge.

Frost damage
typical along bottom
portion of abutment
close to the river

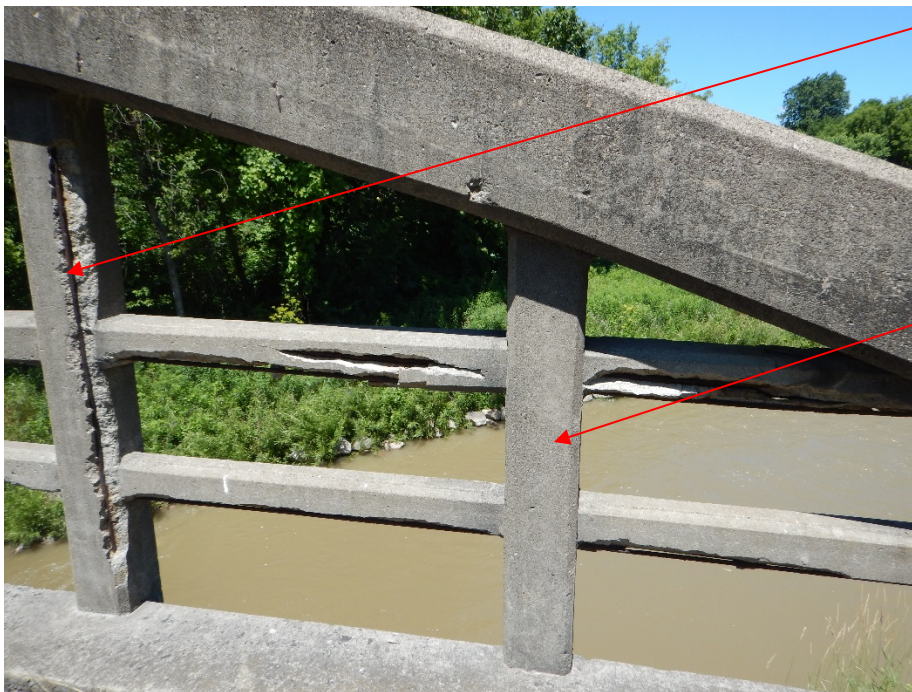
Loss of concrete cover to the vertical hanger steel as a result of spalling

Some hangers remain in good shape

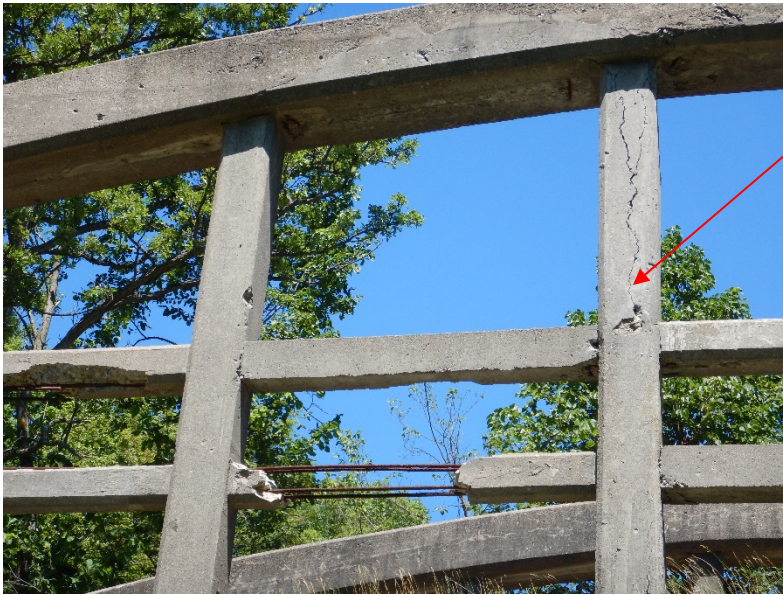
Crack and delamination in upper section of a hanger.

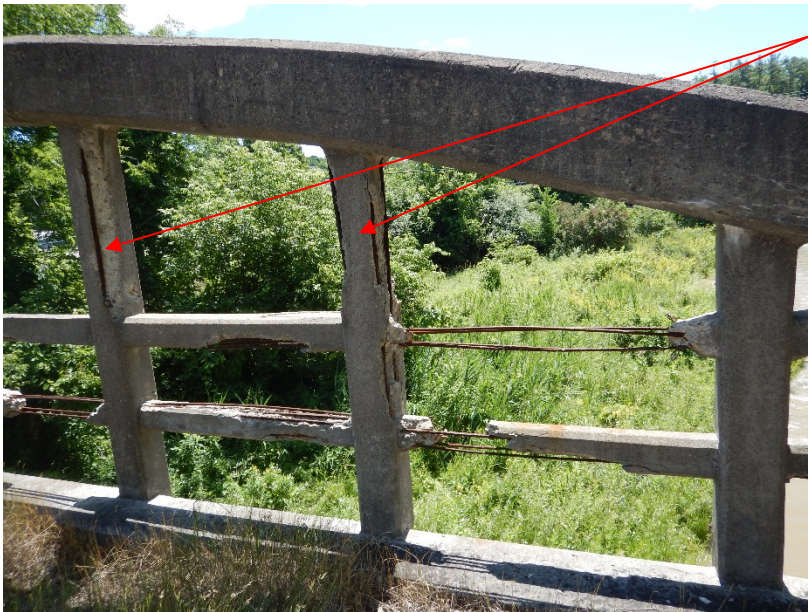
Loss of concrete cover to the vertical hanger steel as a result of spalling

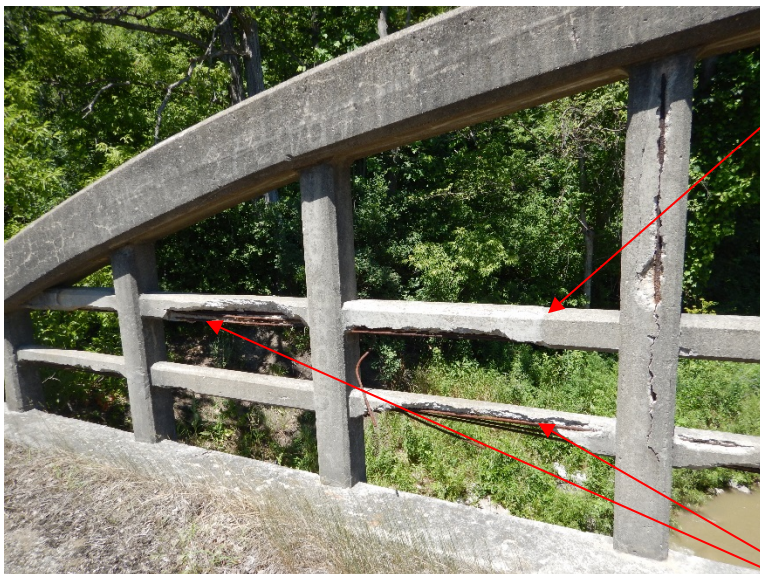
Typical Rail

The railing is the component of the structure with the most visible distress. Sections of the railing are severely delaminated and/or spalled, with some sections of railing completely missing. The railing unit is generally not repairable and will need full replacement. It is assumed at this time that the railing will be replaced with a similar unit.

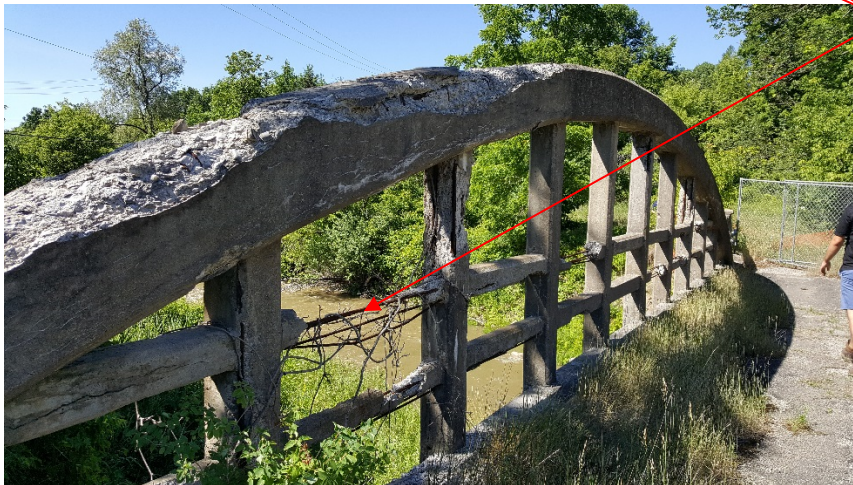
Failed rail with rail rebar
exposed along South Arch
