City of Vaughan

Structural Existing Conditions Report for the Humber Bridge Trail Bowstring Arch Bridge Class Environmental Assessment – Draft for Discussion

November, 2010

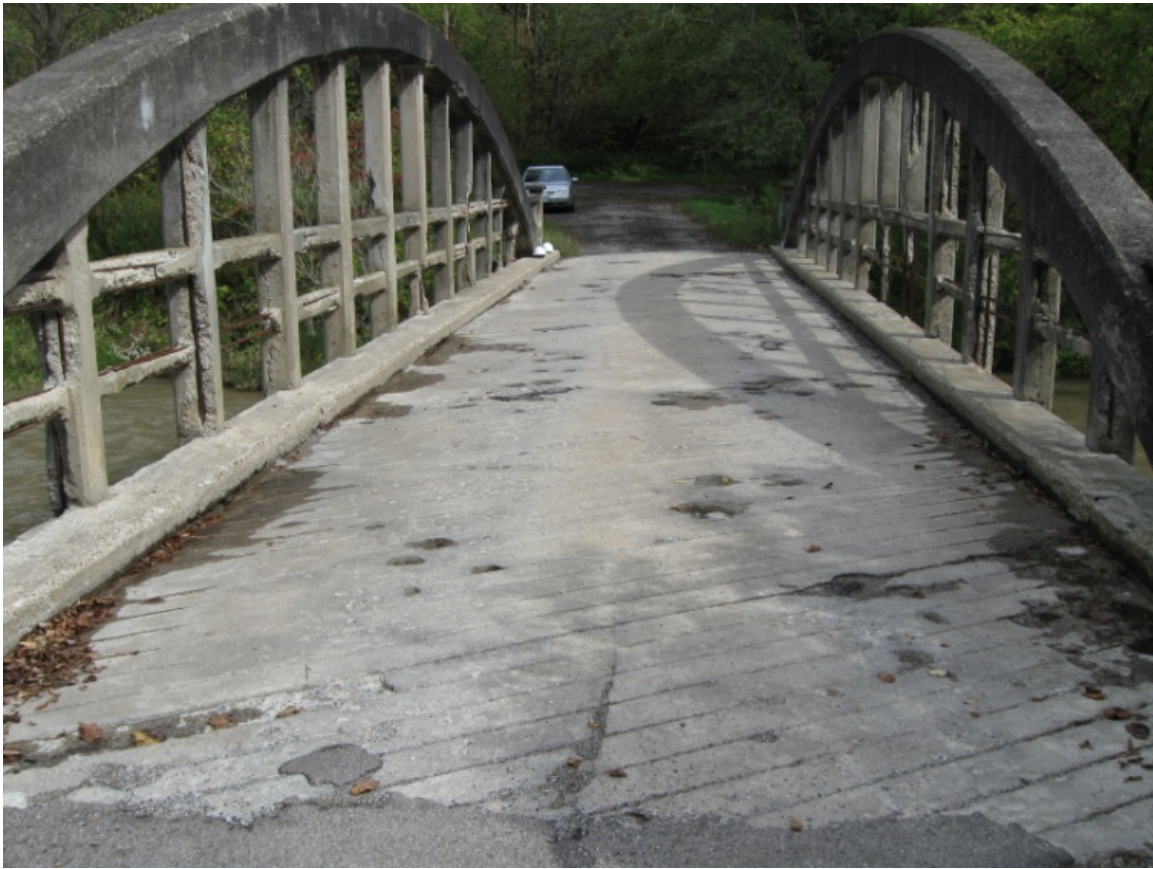
The deck top was in fair to poor condition. Half of the deck area was in poor condition with large cracks and potholes (See Photo 1 of Appendix A).

Photo 1 Bridge Deck showing cracks and potholes

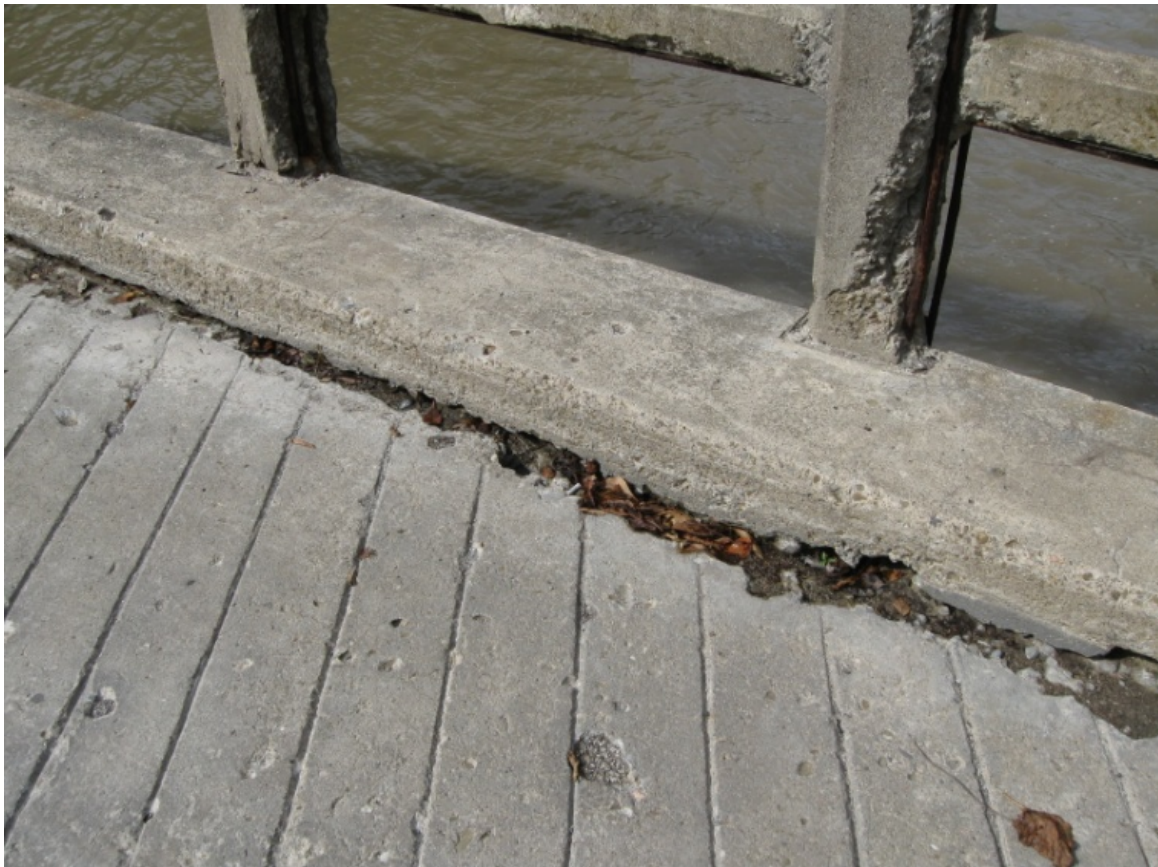
Photo 2 Curb on Deck

The curbs were in good to fair condition. There was some scaling, especially in the areas where the curb meets the deck (See Photo 2).

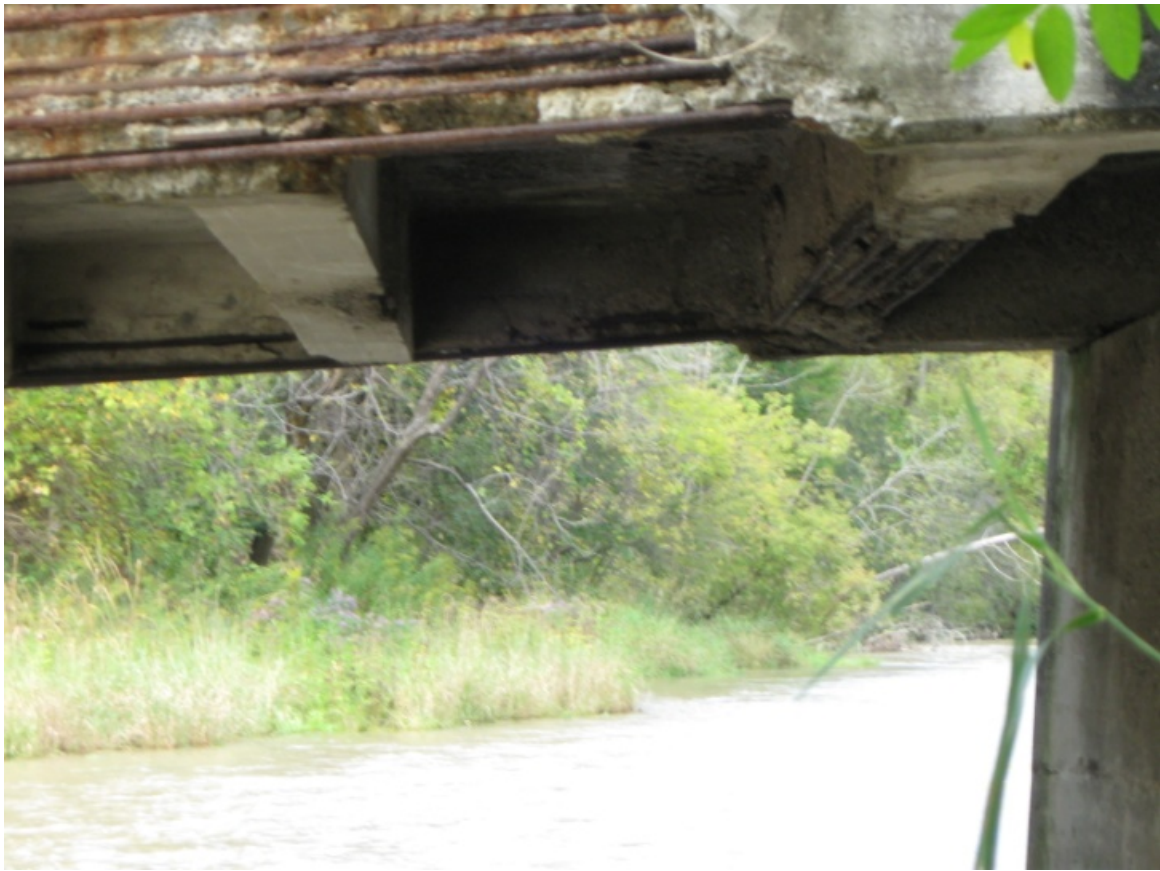
Access to the cross beams was limited due to high water condition. The cross beams seemed to be in fair to poor condition. There was scaling to the side faces. Most beams also showed delamination to the bottom face with corrosion of the bottom reinforcement bars. One beam was observed with severe delamination and exposed bottom reinforcement bars (See Photo 3).

Photo 3 Cross Beams showing spalling

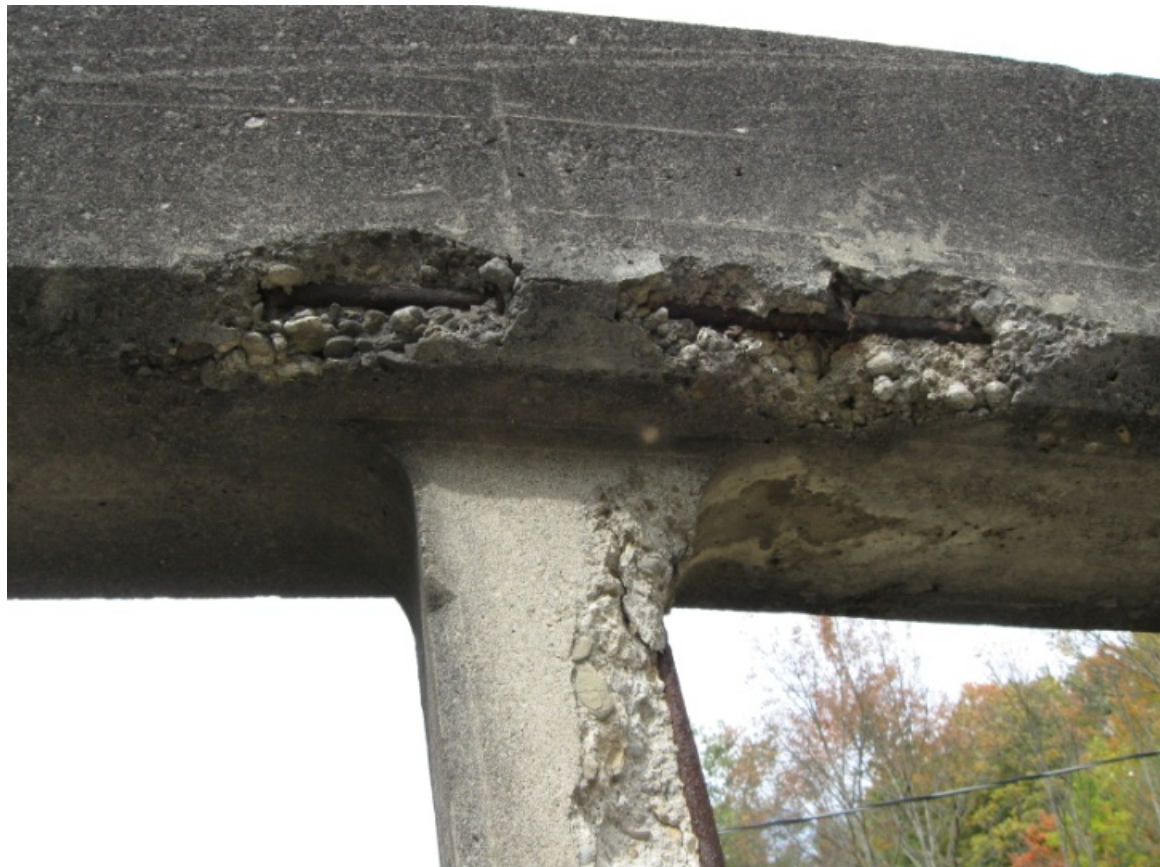
The arches which make up the top chord of the truss were in fair to poor condition. There was some minor scaling to all surfaces. There were also some areas of spalling, especially where the vertical spandrel members connect in to the arch (See Photo 4).

Photo 4 Truss Top Chord showing spalling

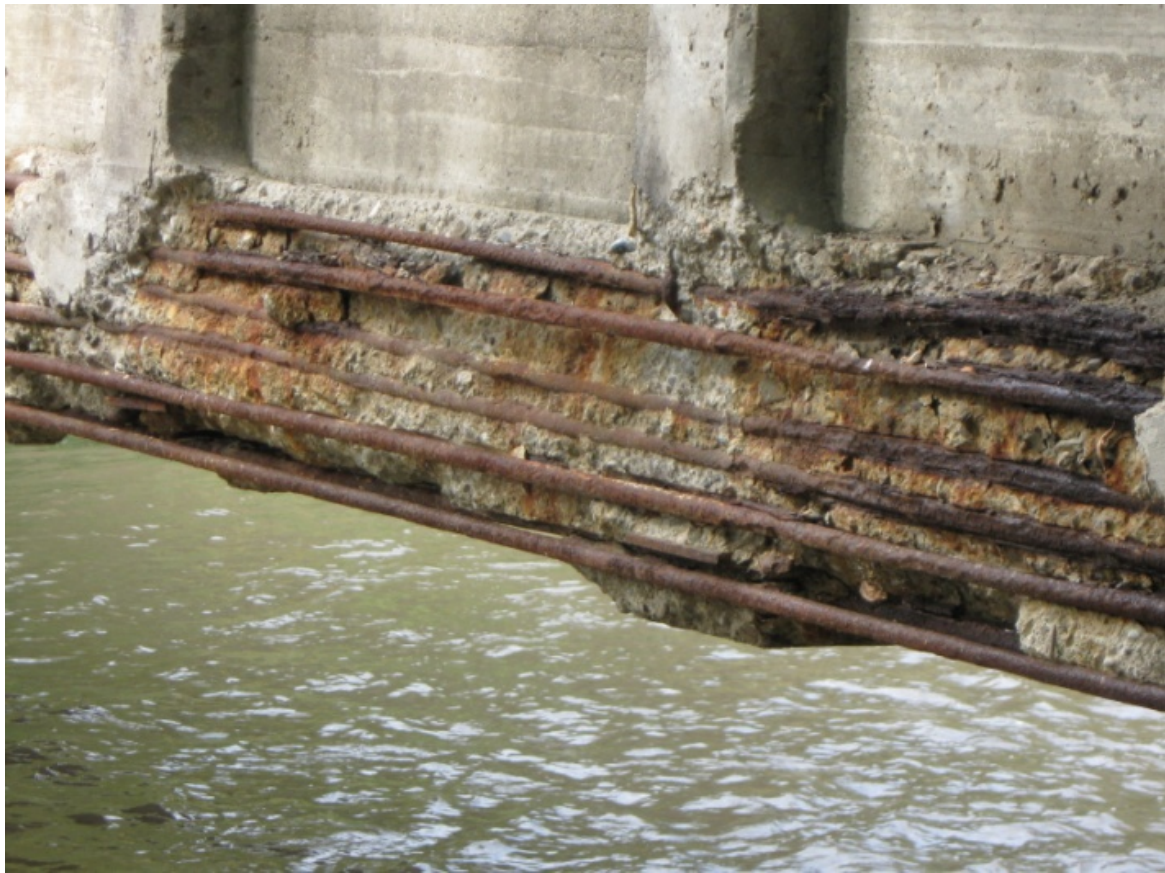
The bottom chords of the trusses were both in very poor condition, with severe delamination and scaling, and the majority of reinforcement bars were exposed and heavily corroded (See Photo 5).

Photo 5 Truss Bottom Chord showing severe spalling

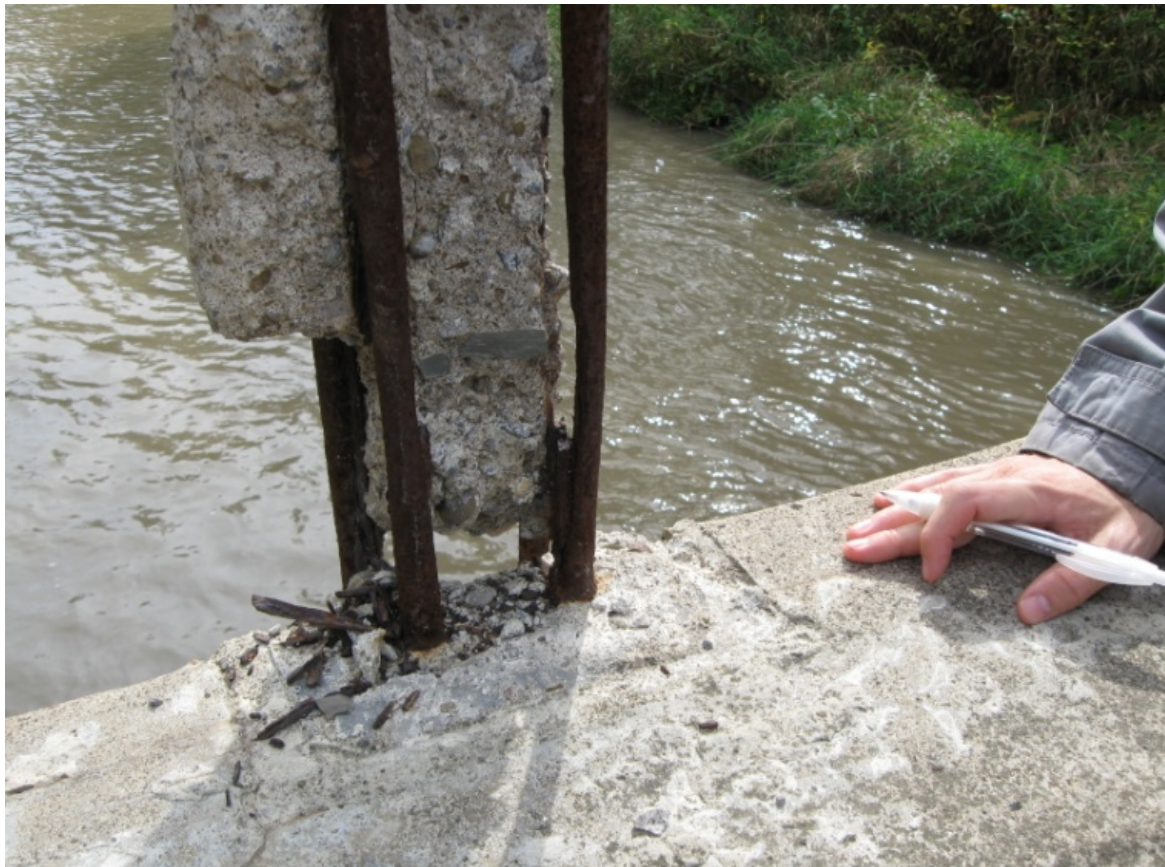
The vertical spandrel members were in poor condition. All showed delamination . For many, the concrete had spalled away in entire sections, leaving reinforcement bars exposed and heavily corroded (See Photo 6).

Photo 6 Vertical Spandrel Member showing severe spalling

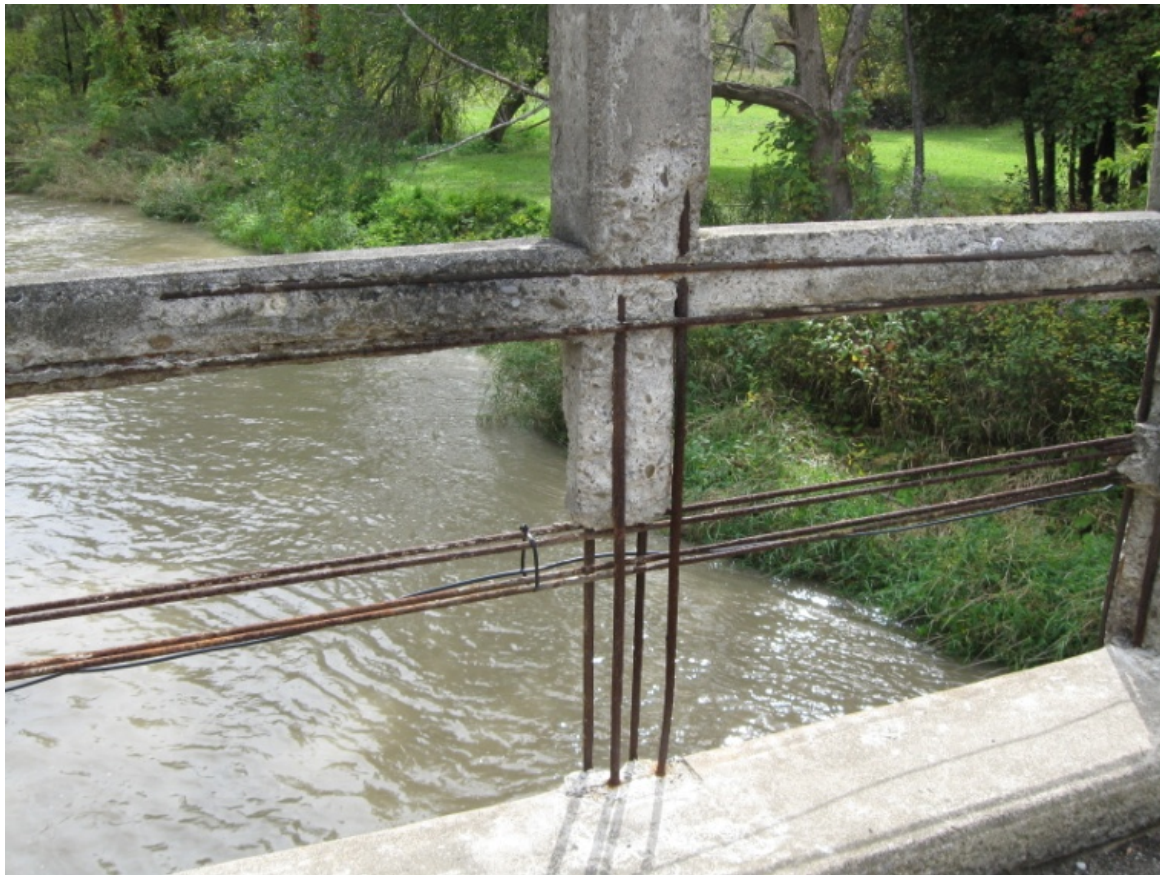
The horizontal spandrel members were in poor condition. All showed delamination. For many, the concrete had spalled away in entire sections, leaving reinforcement bars exposed and heavily corroded (See Photo 7).

Photo 7 Vertical and Horizontal Spandrel Members showing severe spalling

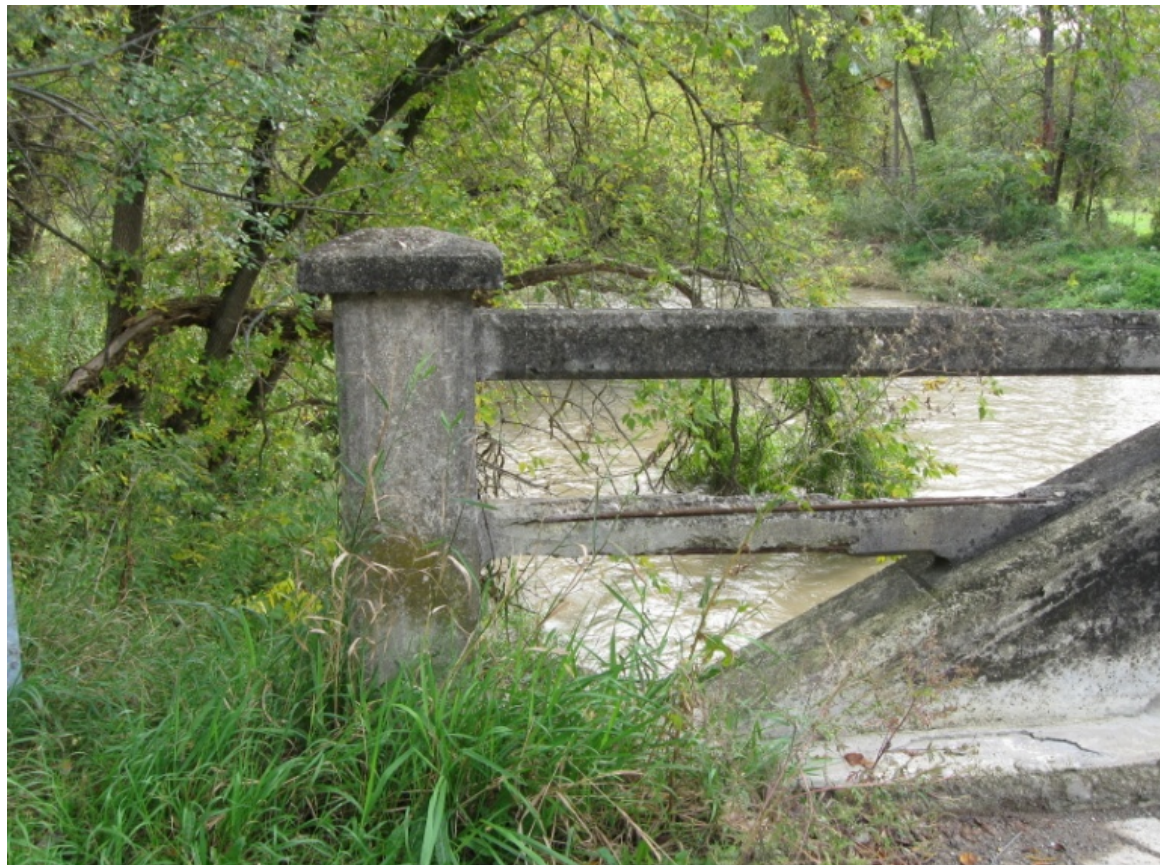
Handrails at either end of the bridge were in poor condition, suffering from delamination and spalling (See Photo 8).

Photo 8 Handrail showing delamination

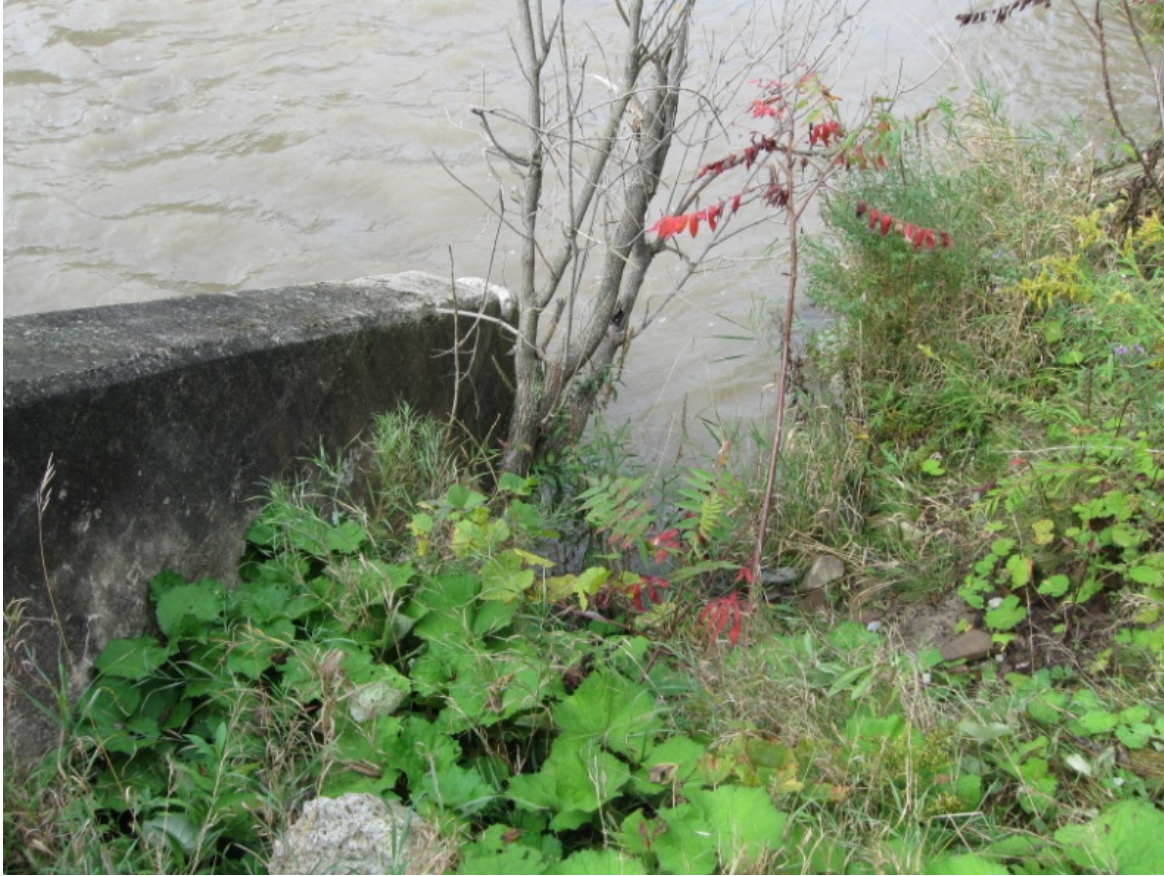
Photo 9 Wingwall

The wingwalls were in good to fair condition. There was some scaling but no delamination. There was no evidence of erosion to the concrete itself, although high water levels prevented confirmation of this. However serious erosion to the soil was observed behind the north-west wingwall (See Photo 9).
